## Christchurch Art Gallery Te Puna O Waiwhetu Base Isolation Retrofit

**Project Location:** Christchurch

**Ruamoko Solutions & Aurecon NZ for Christchurch City Council and Fulton Hogan**

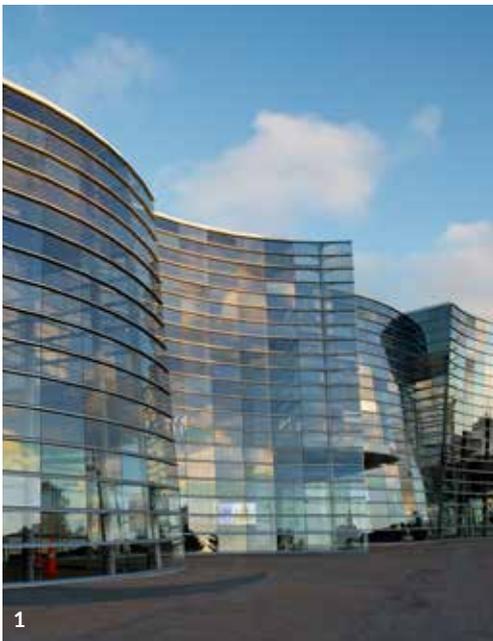
1 Sculptural facade and courtyard following retrofit works (Auercon / Tony Stewart) 2 Temporary support works to northern end of the sculptural glazed façade (Christchurch Art Gallery Te Puna o Waiwhetu / John Collie) 3 Seismic trench construction adjacent to the iconic western sculptural facade (Christchurch Art Gallery Te Puna o Waiwhetu / John Collie) 4 Neon artwork by Martin Creed displayed on the south facade, commissioned ahead of reopening (Auercon. / Tony Stewart)
